Date: February 3, 2022

RE: TOPTON BOROUGH HALL AND COMMUNITY POOL – INITIAL STRUCTURAL ASSESSMENT

205 S. Callowhill Street, Tipton, Berks County, Pennsylvania 19562

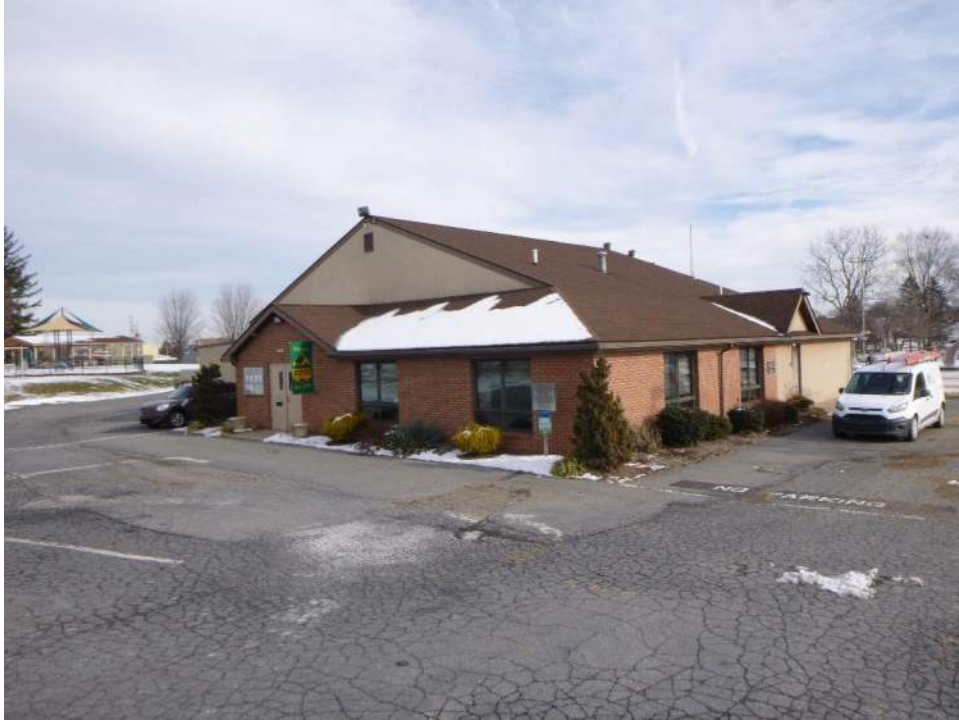
1. The Borough Hall building is a single-story masonry building (see Photo #1). The original building was a pool house, but it was converted into an office building.
2. The exterior wall finishes consisted of stucco and brick wall. No cracking or movement to the exterior wall finishes indicating building settlement were observed (see Photo #2).
3. The grade around the building was flat and consisted of asphalt pavement. The pavement was settled on the left side of the building, and cracks and depressions were noted throughout. No recent movement was noted (see Photo #3).

Photo #1 – Borough Hall building

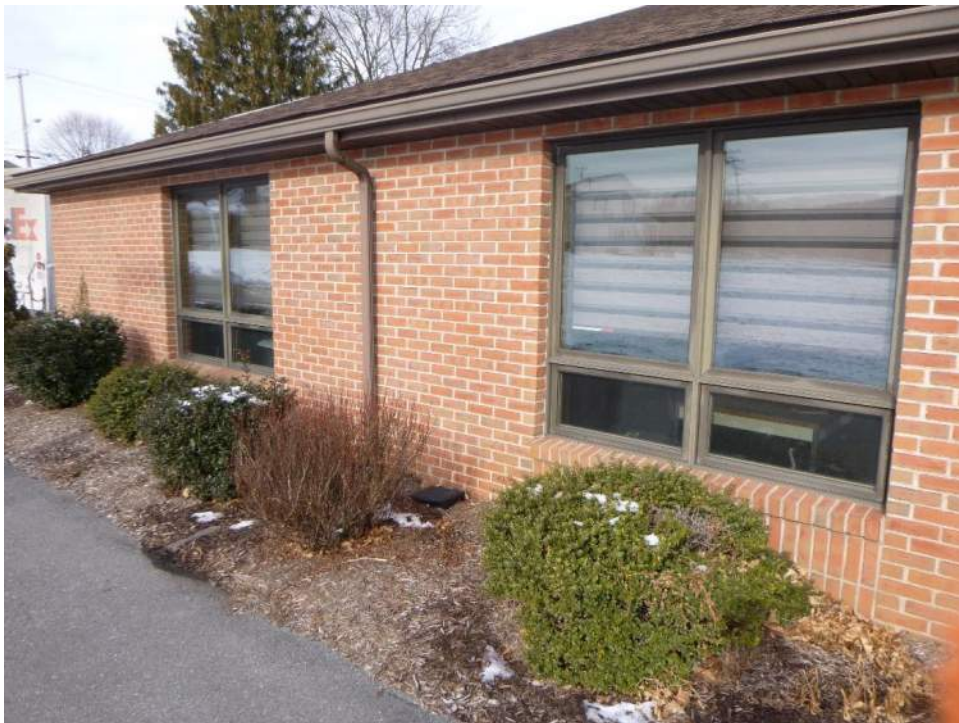
Photo #2 – No damage to exterior wall finishes noted

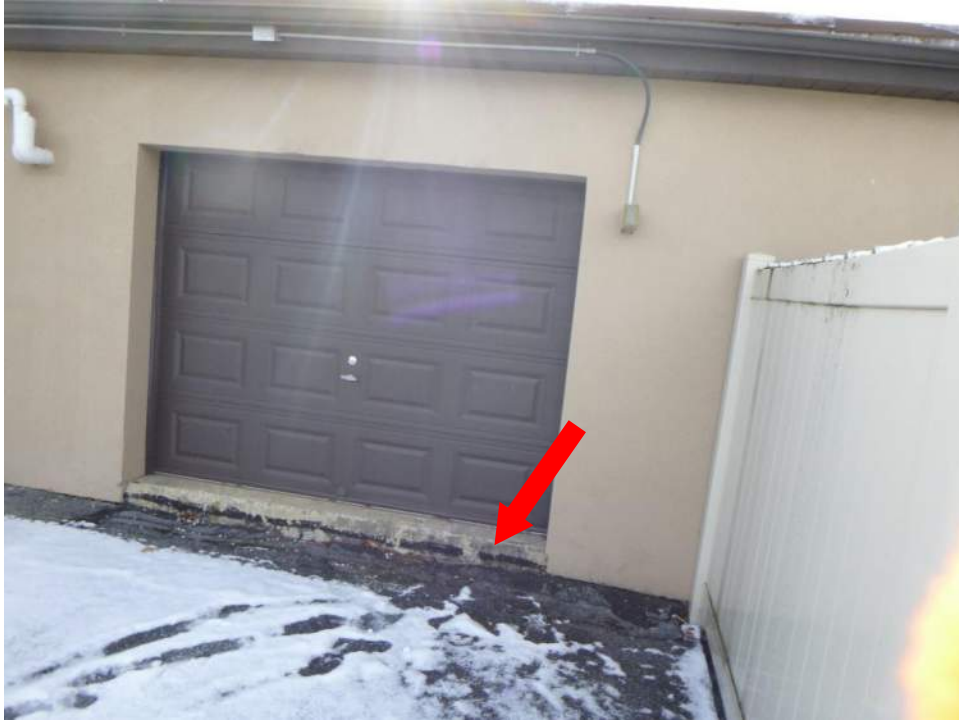
Photo #3 – Settled pavement on left side, cracks and depressions noted

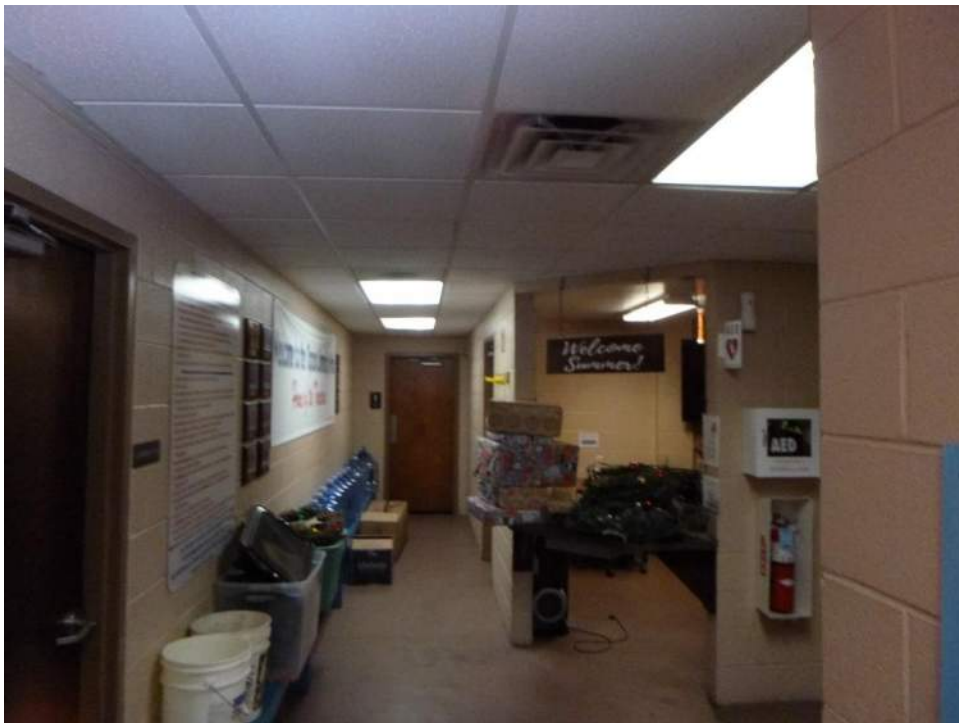
4. No cracking or movement of the interior slabs or wall finishes were noted (see Photo #4).
5. The community pool is located behind the building. The pool consisted of a larger deep pool toward the north and a smaller shallow pool toward the south. The larger pool was partially divided by a wall (see Photo #5).

Photo #4 – No cracking or movement of slab or wall finishes

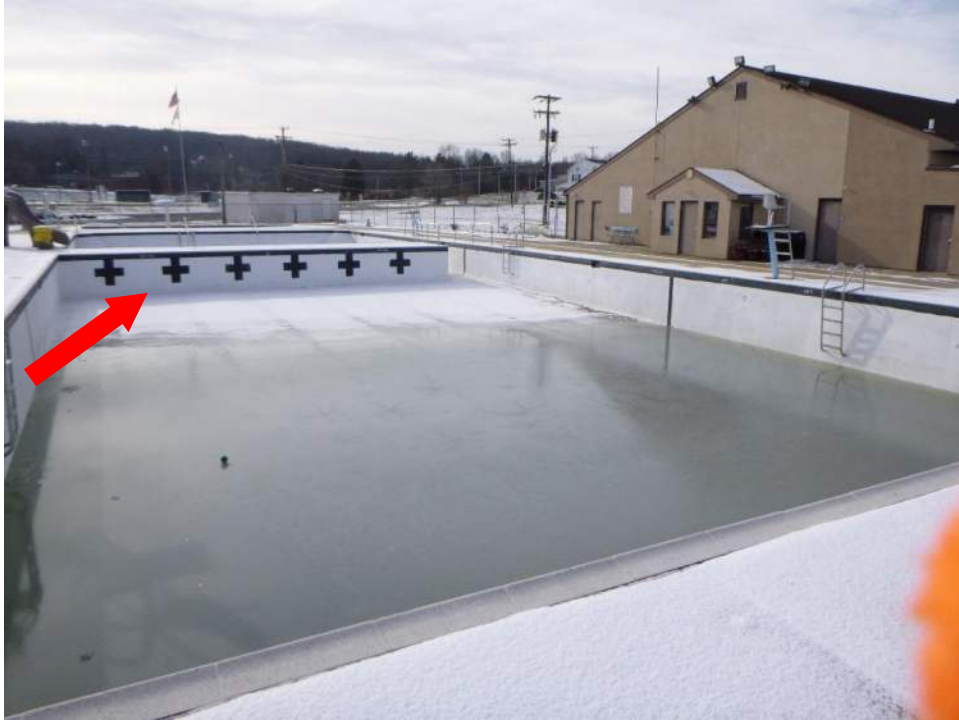
Photo #5 – Larger pool, and dividing wall (arrow)

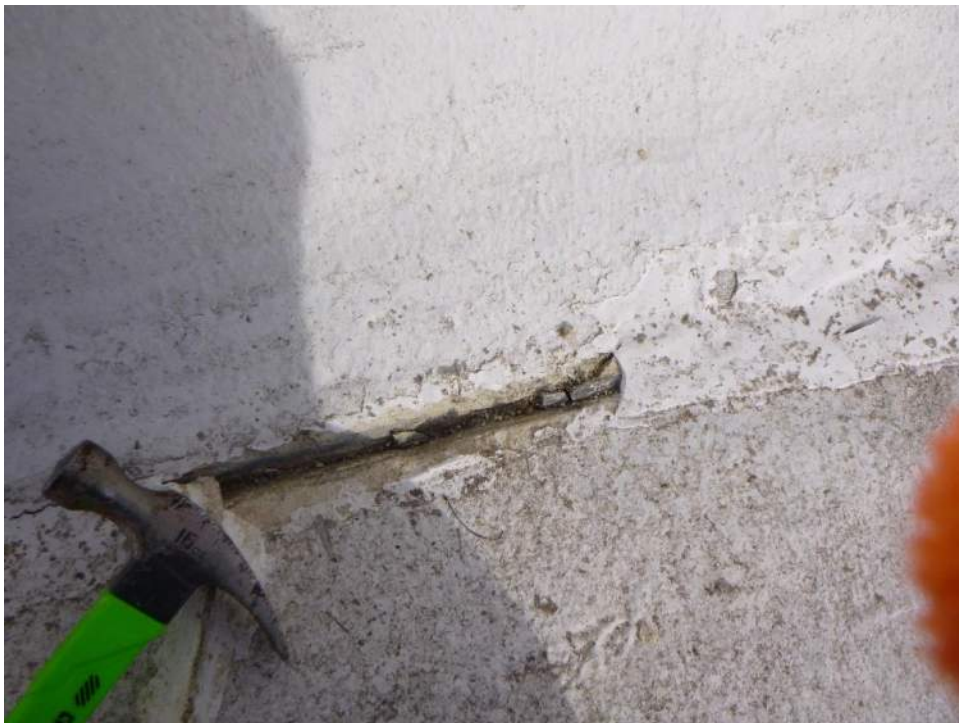
6. Deteriorated sealant and separation between the dividing wall and pool slab were noted along the wall base. The separation measured approximately 1/2-inch (see Photo #6).

The site is underlain by a formation known for sinkhole activity. The loss of water from the pool through cracks in the walls and separation in the pool slab along the dividing wall is significant and can contribute to sinkhole formation under the pool. The hollow-sounding pool slab indicates that there is a void under the slab; however, the extent and significance of the void is unknown.

Photo #6 – Deteriorated sealant and separation between dividing wall and pool slab

Isett recommends that further investigations of the subgrade are performed to determine if there is a sinkhole under the pool. The investigation should be performed by a Professional Geologist and/or Geotechnical Engineer and may include but not be limited to:

1. A geophysical survey of both pool slabs and adjacent lot, as well as accessible areas on the first floor of the Borough and Water Control buildings.
2. A geotechnical engineering study, including the advancement of standard earth borings at the exterior of the Borough Building and the pool.

Until the void can be diagnosed and repaired, and the pool structure repaired, the pool should not be used or occupied.

A structural engineer should work with the geotechnical engineer to develop the appropriate repairs to the void and the pool.

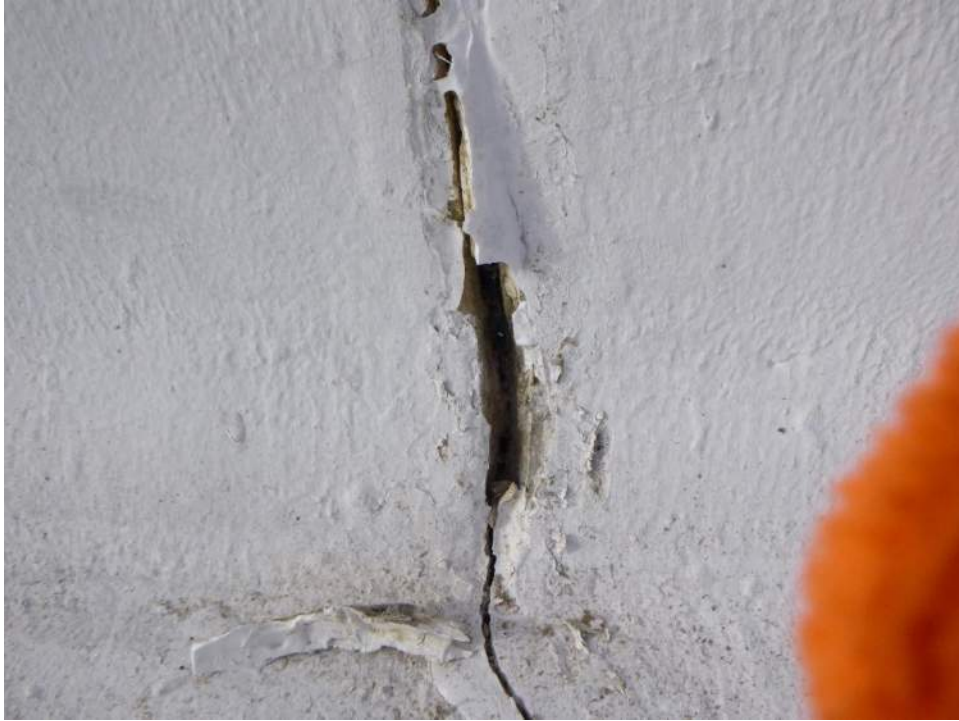
8. A crack measuring approximately 1/2-inch in the pool concrete wall near the west end of the dividing wall was noted. The crack extended from the top of the wall through the pool concrete slab and continued toward the dividing wall. The crack was previously sealed, but the sealant was deteriorated and missing (see Photo #7).

Photo #7 – Crack in pool wall and slab, deteriorated sealant

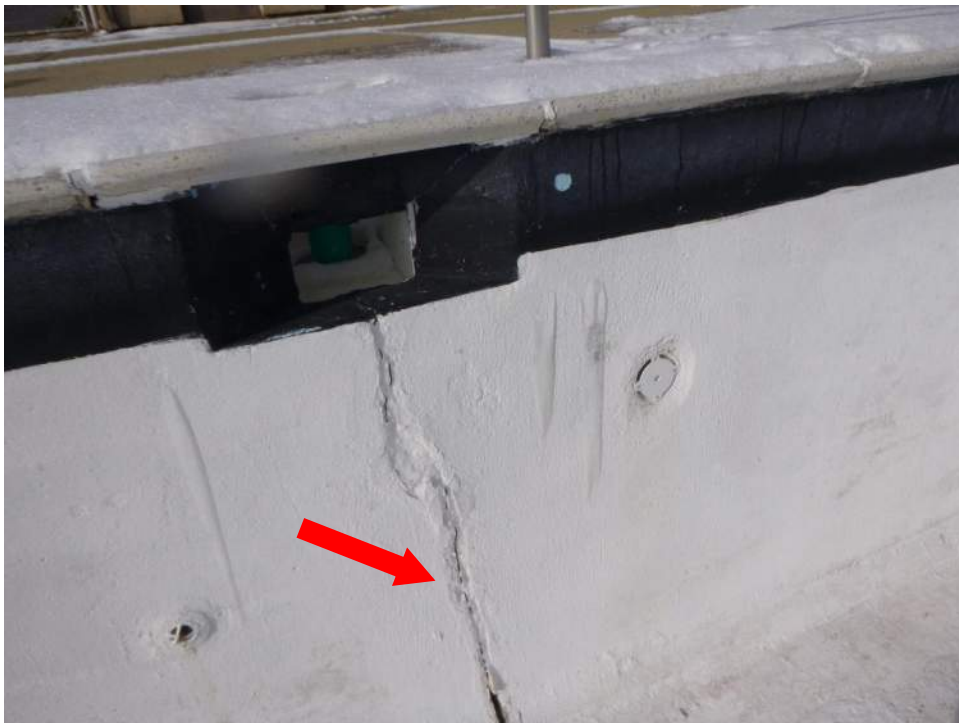
9. Cracks in the pool walls were observed in multiple locations. Some cracks were sealed but the sealant was deteriorated. The cracks varied in length and width, and were from hairline to approximately 1/4-inch wide (see Photos #8 and #9).

Photo #8 – Cracks in pool walls in multiple locations

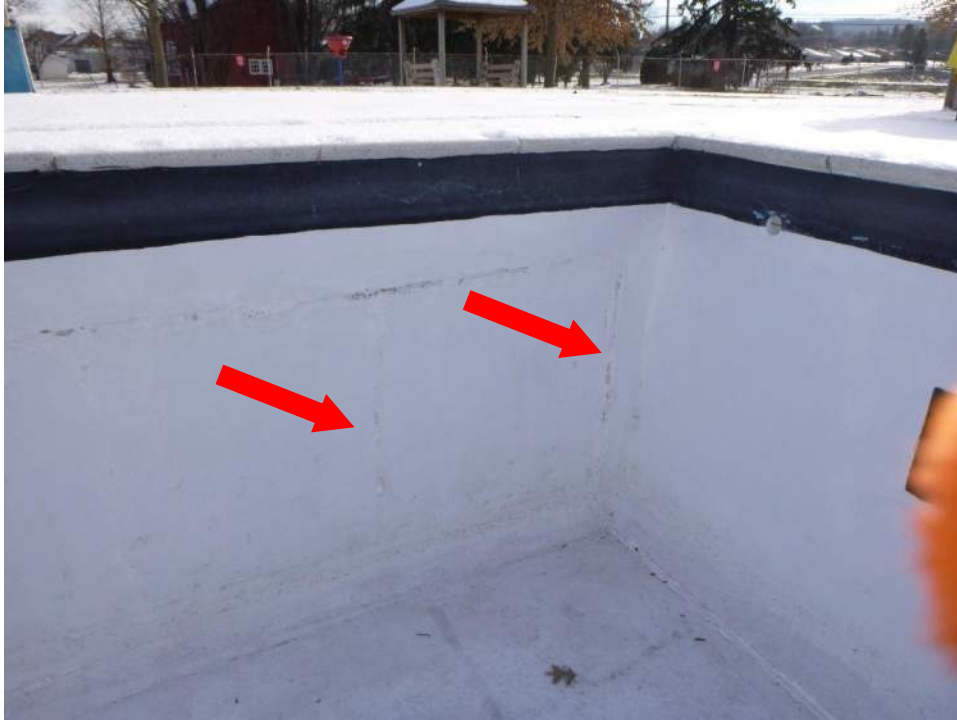
Photo #9 – Cracks in pool walls in multiple locations

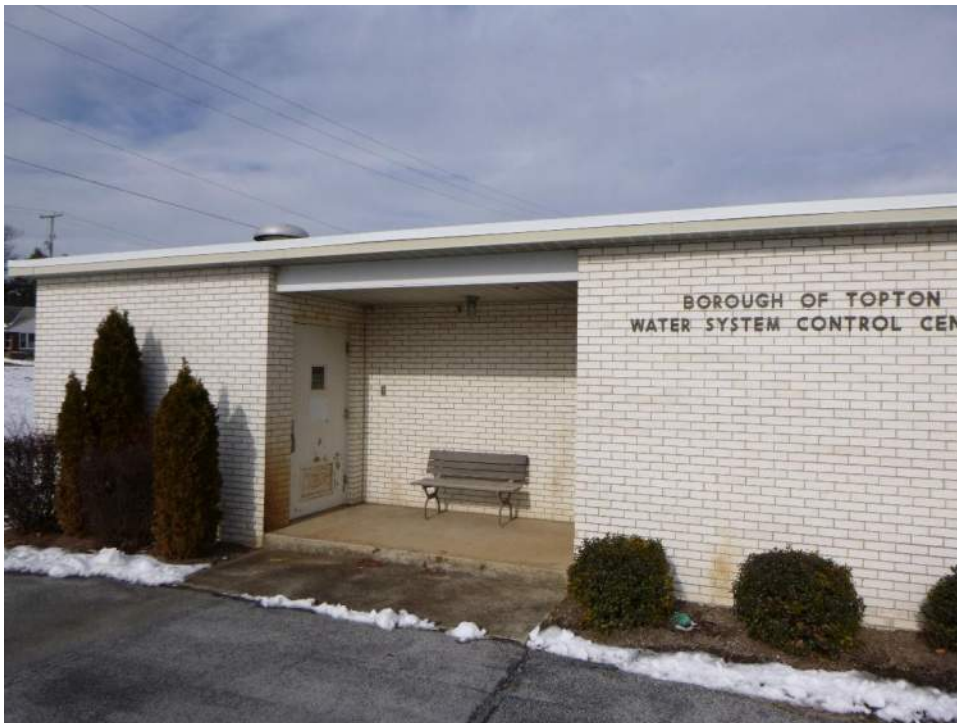
10. Most of the pool slab was covered with ice and could not be assessed.
11. No deterioration to the smaller pool was noted.
12. No cracking or movement to the Water Control building was noted (see Photo #10).

Photo #10 – No cracking or movement of Water Control building
