**APPLIED GEOSCIENCE & ENGINEERING, INC.**

May 31, 2011

Subject: Heaving and Subsidence Investigation  
Borough of Tipton Community Swimming Pool  
Tipton, Berks County, PA  
AG&E Project # TB-1020

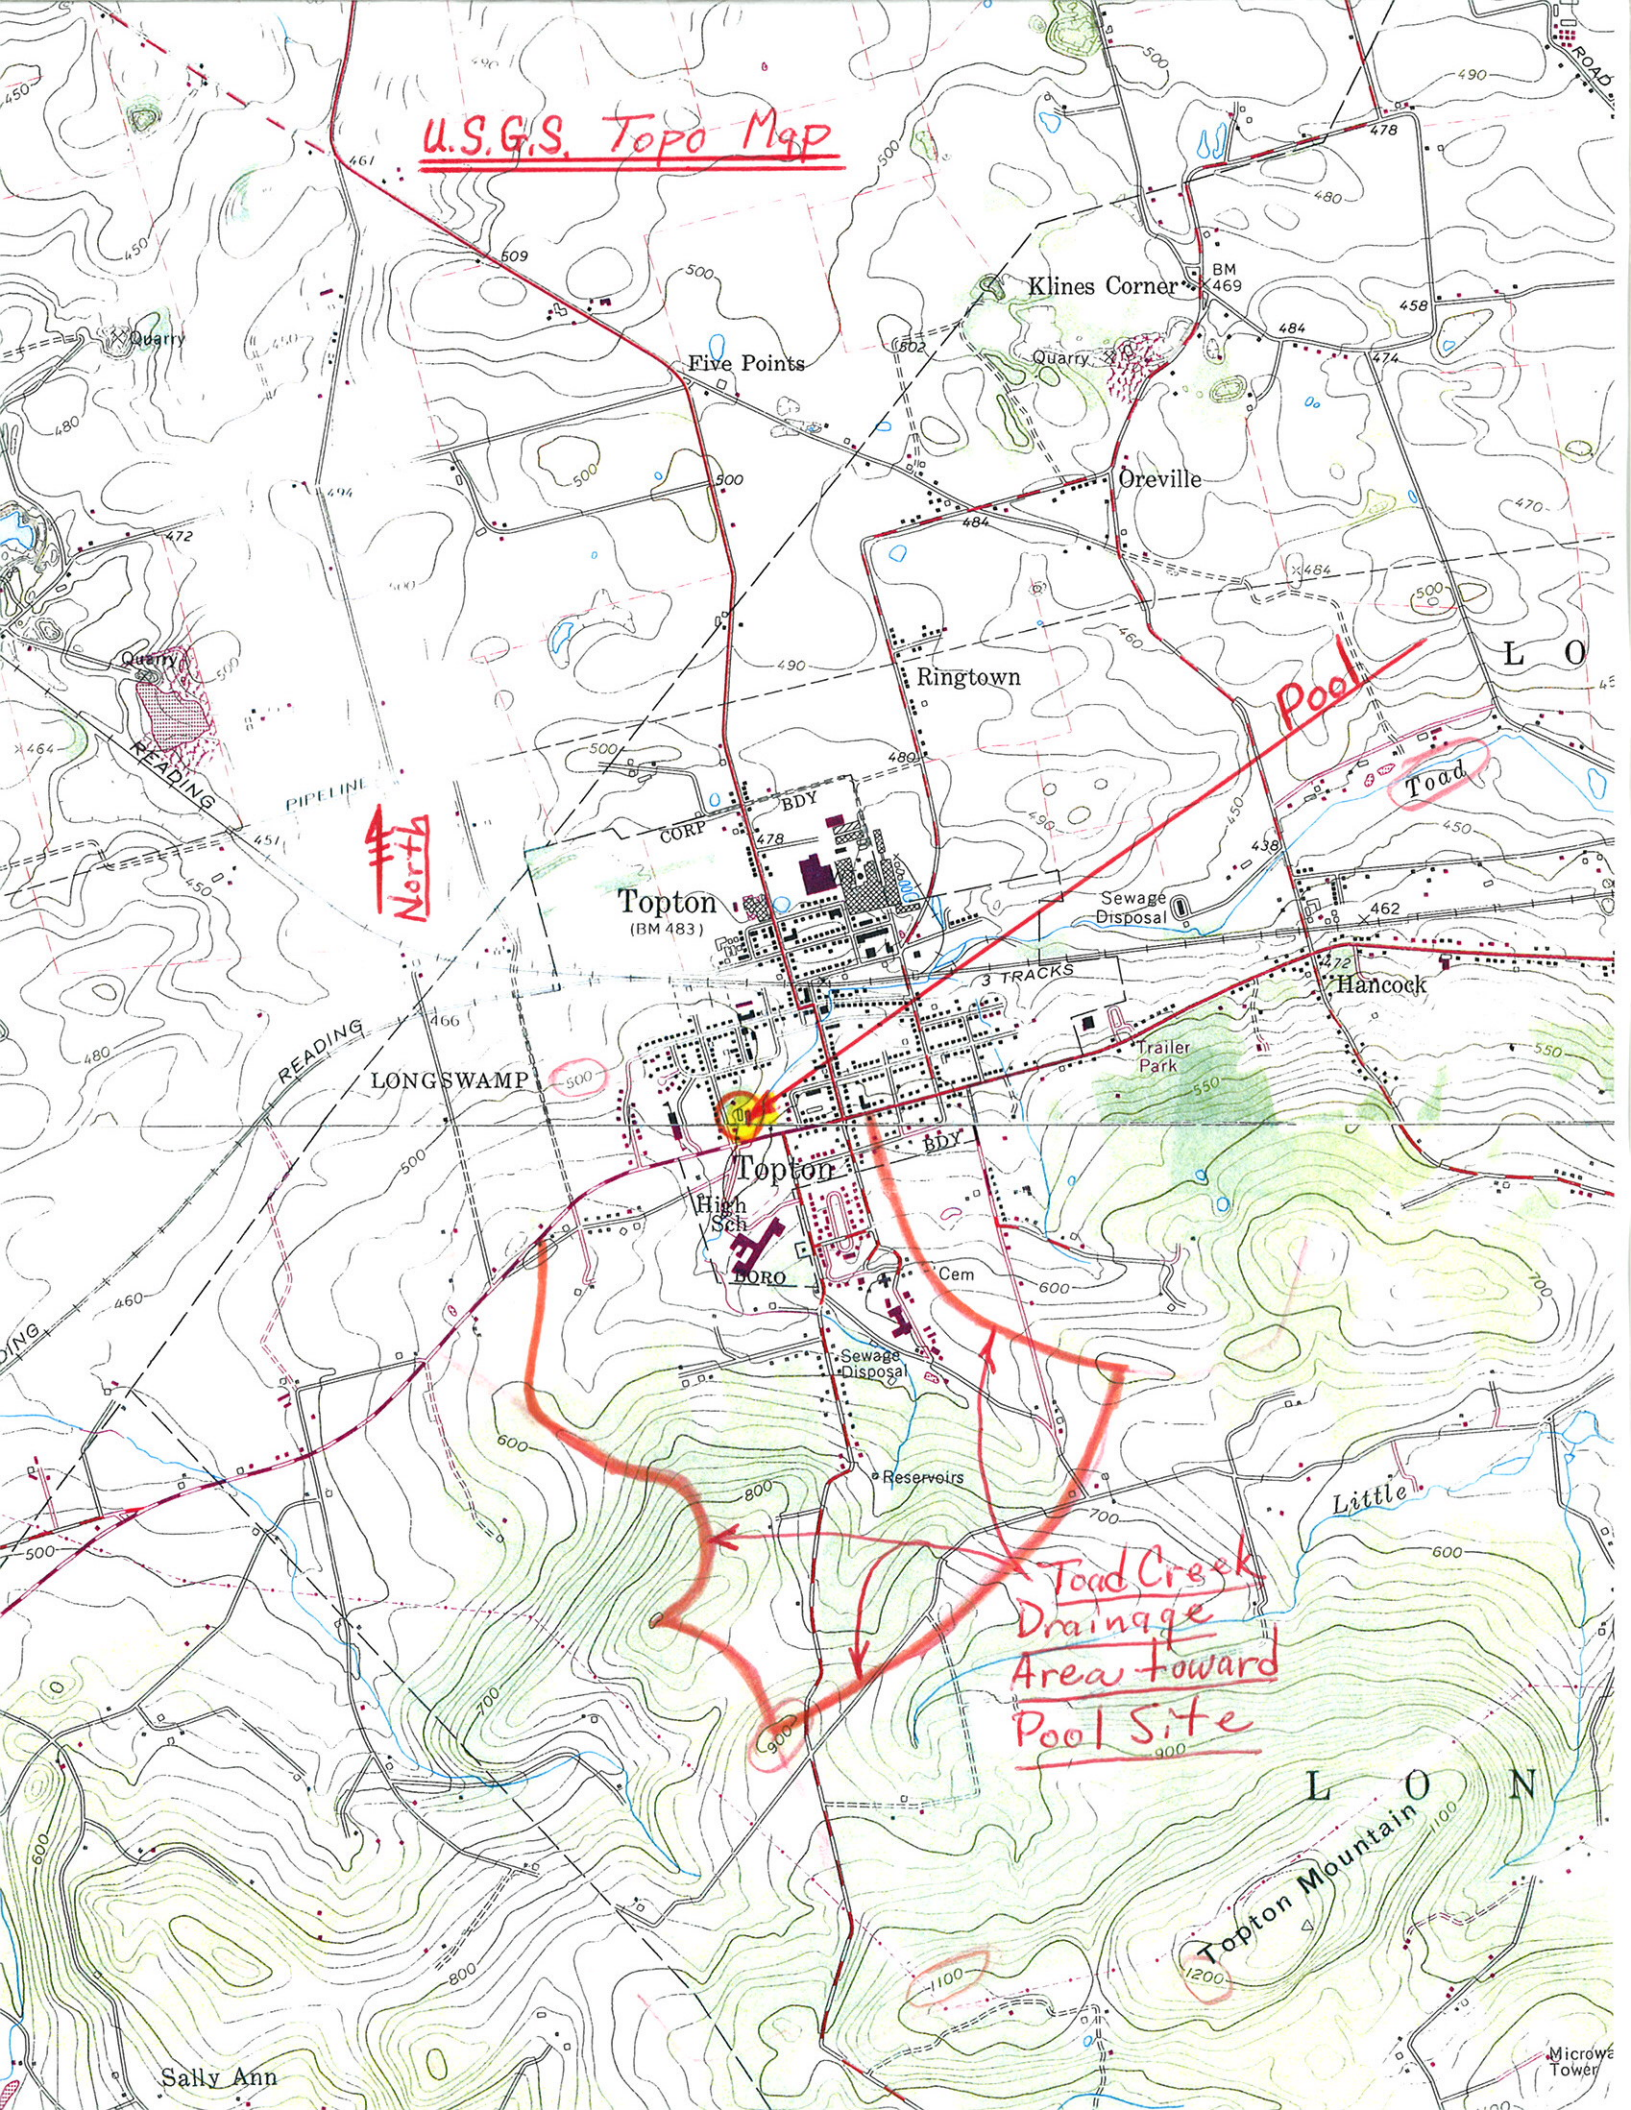
U.S.G.S. Topo Map

- There are numerous springs and wetlands upslope of the pool property, to the south and southwest of the property. The Tipton Mountain, which is located southeast of the pool property, appears to be approximately 700-feet higher than the pool property, as can be observed from the USGS Manatawny Quadrangle Topographic mapping, a copy of which is attached herewith. Also noted on this map is that the south end of the drainage area draining to the Toad Creek is approximately 400-feet higher than the pool property; this south end of the drainage area is approximately 6,500-feet due south of the pool. This drainage area appears to be in excess of 500-acres in area upstream of the pool property.

Toad Creek  
Drainage  
Area toward  
Pool Site

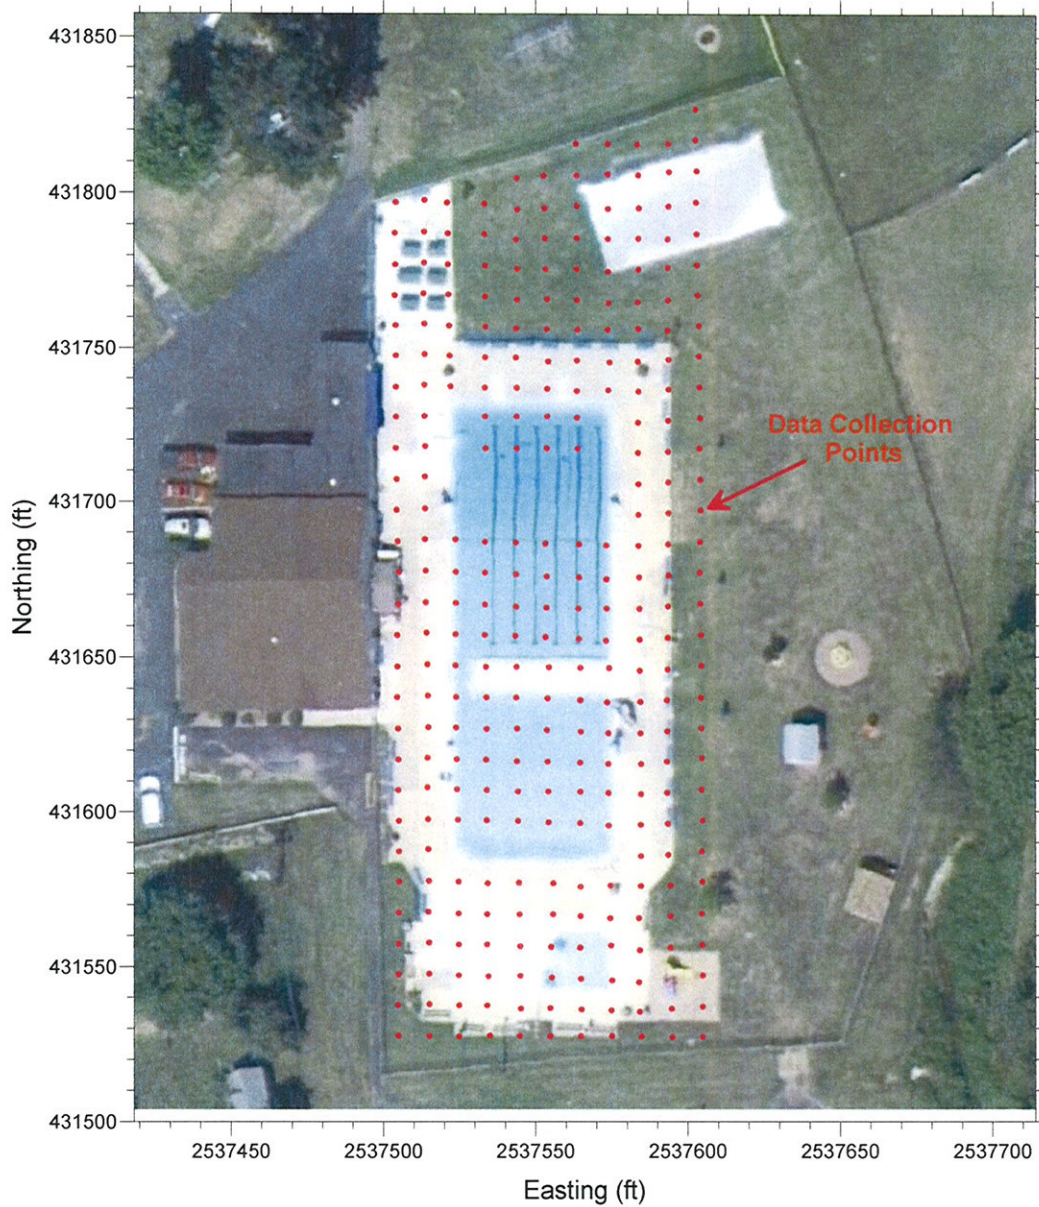
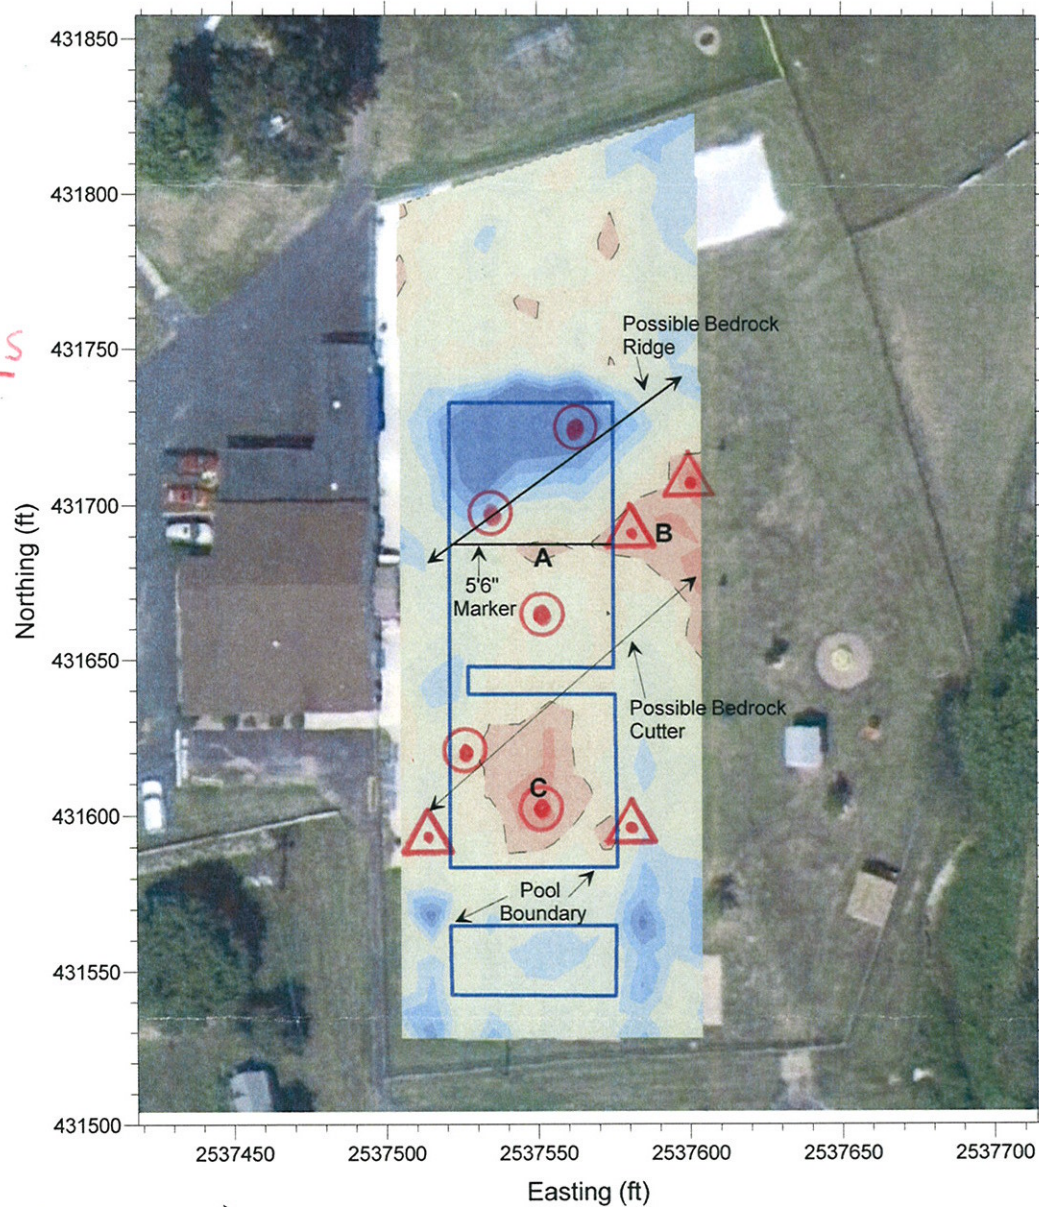
In March, 2011, the Borough had a geophysical survey performed by Environscan, Inc., which resulted in Environscan's April 7, 2011 Final Report to the Borough of the Geophysical Survey results. The report indicated 3-mass deficient/low bedrock areas within and around the pool, and another mass excess/high bedrock area within the deep end of the pool; these areas are shown on the attached copy of Environscan's Report Figure 1. Cracks also were observed in the pool upon dewatering the pool for the geophysical survey.

- On March 2, 2011, Environscan, Inc., a Geophysical Survey firm from Lancaster, PA, prepared a proposal to the Borough, at their request, to prepare a Subsidence Characterization Geophysical Survey of the pool. Upon acceptance by the Borough, Environscan performed a microgravity and ground penetrating radar (GPR) survey of the pool and the surrounding pool decking. That survey resulted in an April 7, 2011 Final Report of the Geophysical Survey, which included mapping of the soil and rock beneath the pool area, a copy of which is included in Figure 1.

- c. Additional shallow unsampled borings also are proposed within the pool perimeter through existing cracks in the bottom of the pool, in order to investigate the soil and rock conditions beneath the cracks, including the mass-deficient area shown by Environscan along the 5'6" Marker.

1. Following the close of the 2011 pool season, it is recommended that subsurface borings be obtained beneath the pool, with a few borings through the pool walls at representative locations if possible. Potential boring locations are indicated on the attached copy of Environscan's Figure 1. These borings will be reviewed and evaluated accordingly in order to plan appropriate corrective measures recommendations.

- a. Approximately 5-deep sampled borings, from 10- to 20-feet into rock, are proposed from the bottom of the pool, within the pool perimeter, as indicated in Figure 1, in order to investigate the soil and rock conditions beneath the bottom of the pool.

- b. Approximately 4-shallow unsampled borings are proposed through the concrete deck surrounding the pool perimeter, as indicated in Figure 1, in order to investigate the soil conditions beneath the concrete deck.
