**APPLIED GEOSCIENCE & ENGINEERING, INC.**

May 31, 2011

Subject: Heaving and Subsidence Investigation  
Borough of Tipton Community Swimming Pool  
Tipton, Berks County, PA  
AG&E Project # TB-1020

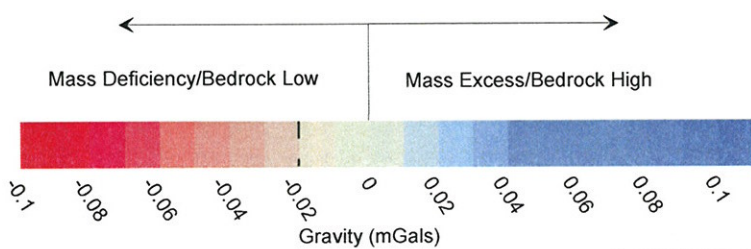
- c. Additional shallow unsampled borings also are proposed within the pool perimeter through existing cracks in the bottom of the pool, in order to investigate the soil and rock conditions beneath the cracks, including the mass-deficient area shown by Environscan along the 5'6" Marker.

1. Following the close of the 2011 pool season, it is recommended that subsurface borings be obtained beneath the pool, with a few borings through the pool walls at representative locations if possible. Potential boring locations are indicated on the attached copy of Environscan's Figure 1. These borings will be reviewed and evaluated accordingly in order to plan appropriate corrective measures recommendations.

- a. Approximately 5-deep sampled borings, from 10- to 20-feet into rock, are proposed from the bottom of the pool, within the pool perimeter, as indicated in Figure 1, in order to investigate the soil and rock conditions beneath the bottom of the pool.

- b. Approximately 4-shallow unsampled borings are proposed through the concrete deck surrounding the pool perimeter, as indicated in Figure 1, in order to investigate the soil conditions beneath the concrete deck.
